**Subject: Flushing Bay, Flushing River, and Willets Point Pre-CERCLIS Screening
Scrap King Pre-CERCLIS Screening Form
Contract No.: EP-S5-06-04, TDD No.: S05-0013-1306-003**

PRE-CERCLIS SCREENING/NEW SITE ASSIGNMENT FORM**EPA ID NUMBER: None****SITE NAME: Scrap King****PREVIOUS NAMES (AKAs): None****SITE LOCATION:****Street address: 35-32 College Point Boulevard****City: Flushing****State: New York****Zip code: 11354****County: Queens****BLOCK: 4963****LOT: 212****LATITUDE (decimal degrees): + 40.761897****LONGITUDE (decimal degrees): - 73.835881****a. Accuracy meters: None****b. Collection method: Google Earth****c. Reference datum: None****d. Reference point: Center of property****e. Source map scale: None****f. Point/line/area: Point****g. Collection date: 03/27/14****(See attachment 1 for available values)****AVAILABLE SITE TYPE MAIN CATEGORIES: Recycling****AVAILABLE SITE TYPE MAIN SUBCATEGORIES: Recycling/scrap metals/batteries****(See attachment 2 for available values)****COMPLETE THE FOLLOWING CHECKLIST.**

APPENDIX B
PHOTOGRAPHIC DOCUMENTATION LOG

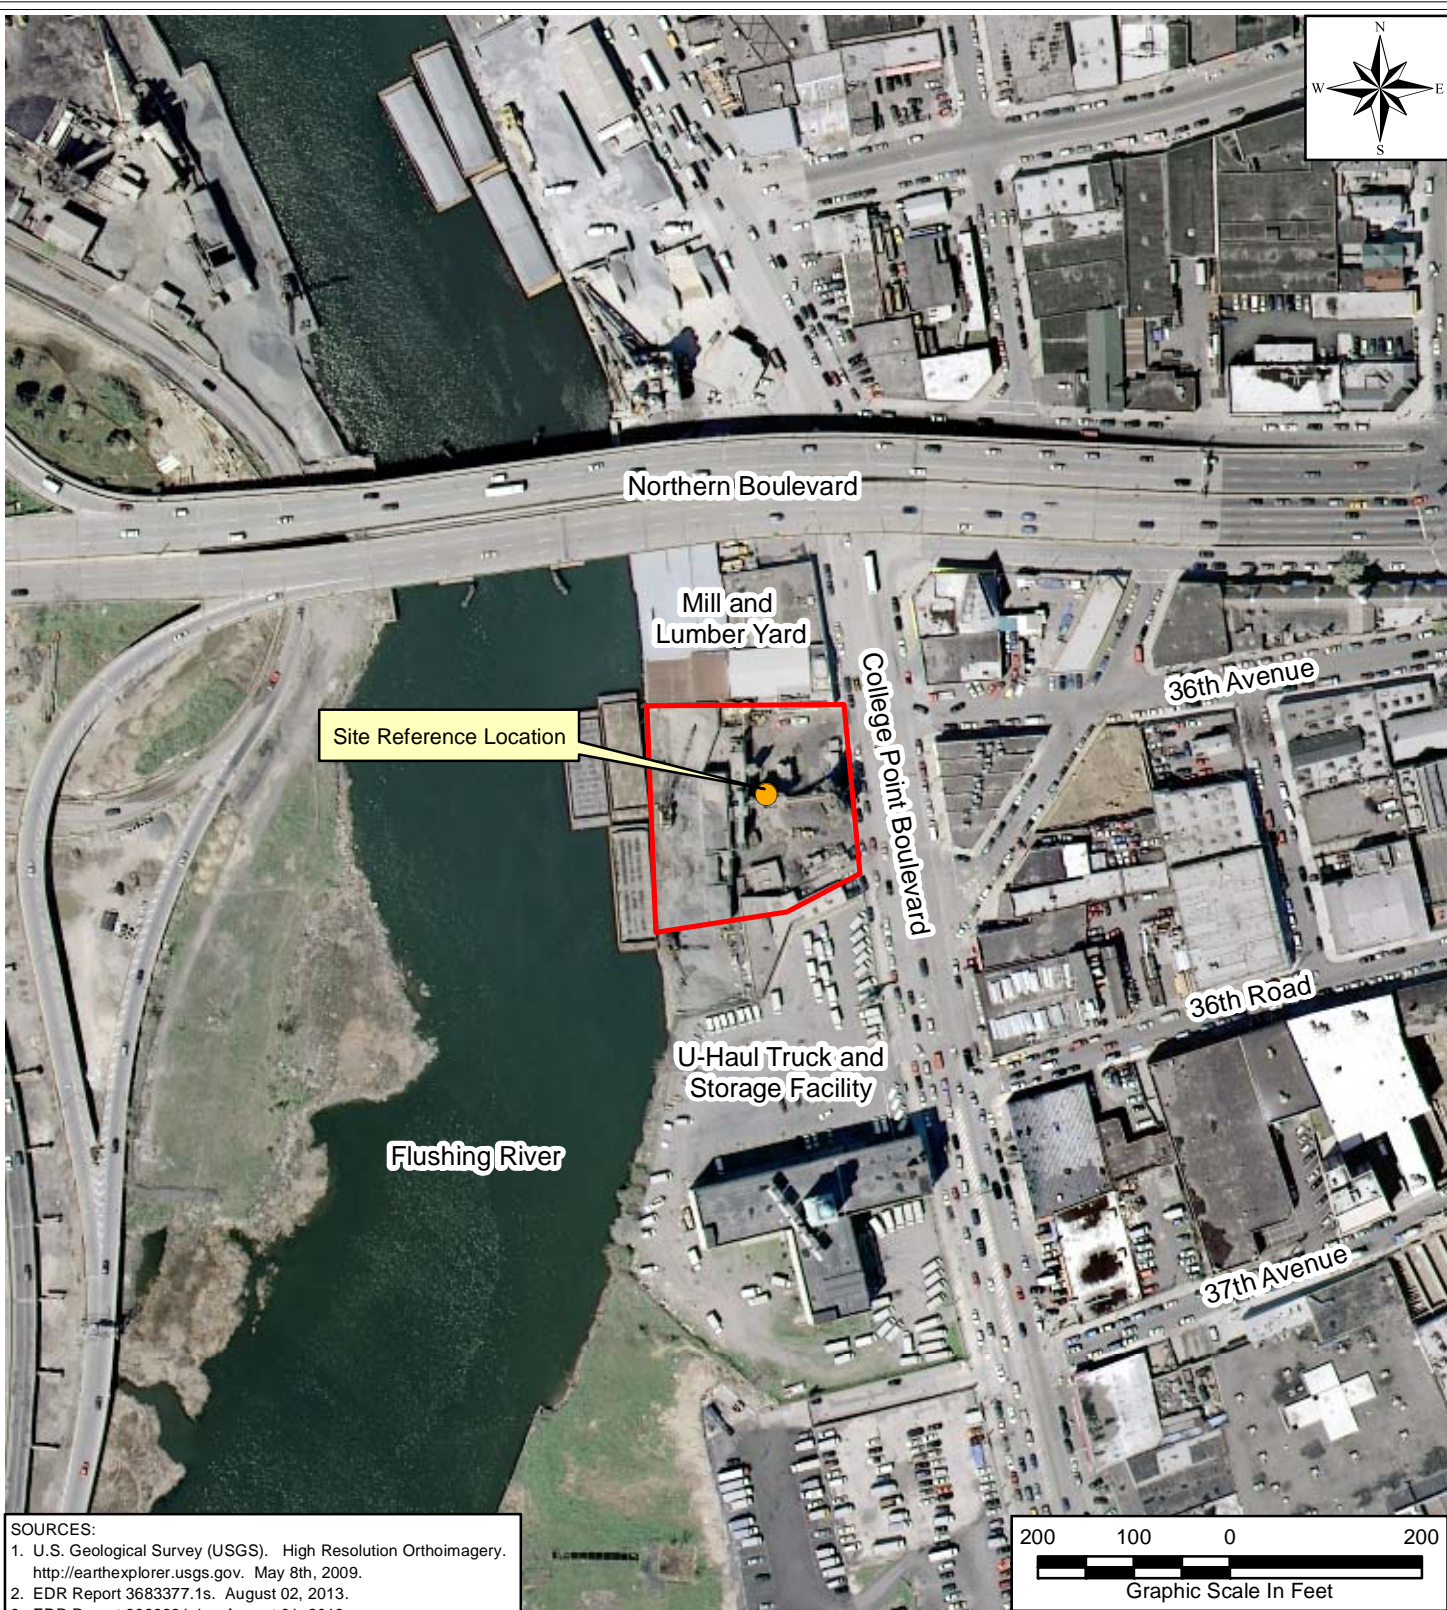
FIGURE #: 2

WESTON did not access the property; however, as can be seen in the attached photographic documentation log and on Figure 2, the property appears to be covered by asphalt with little to no exposed soil. The limited exposed soil was associated with the raised bedding for the landscaping along the fenceline. Pallets and bundles of scrap metal can be seen on the property as well as a contained pile of scrap debris along the eastern boundary of the property.

Site Map
 Scrap King
 35-32 College Point Boulevard
 Queens, NY

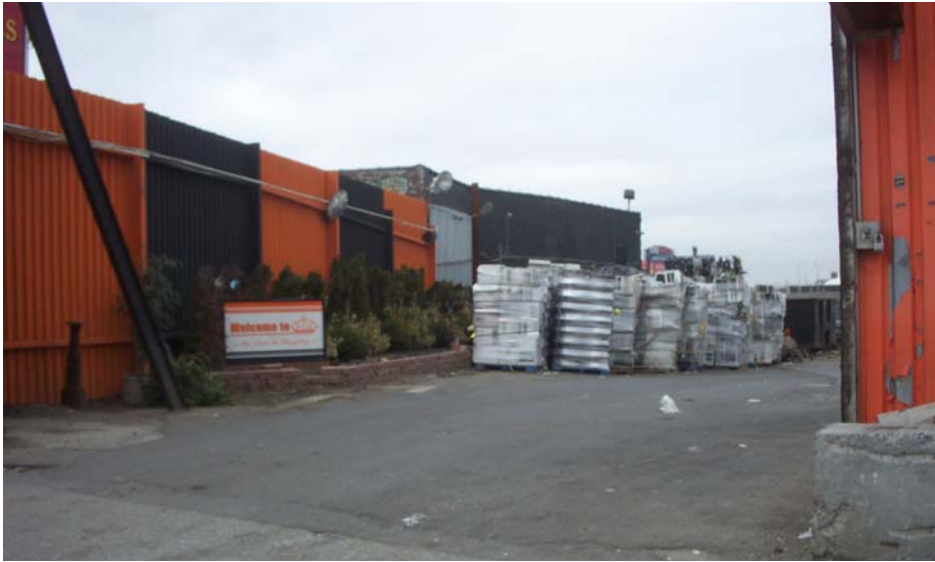
Photograph 1 – Entrance to Scrap King. Standing on sidewalk along College Point Boulevard looking west towards Flushing River.

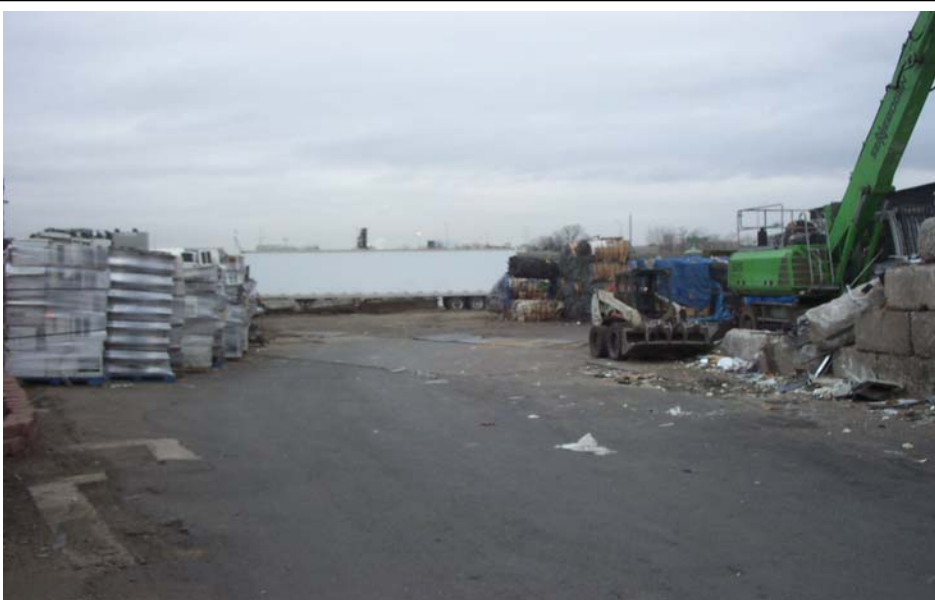
Photograph 2 – Looking northwest into Site property from entrance along College Point Boulevard.
